## VEHICLE INSPECTION REPORT

**PJ66BCF**

### Daf LF 45.150

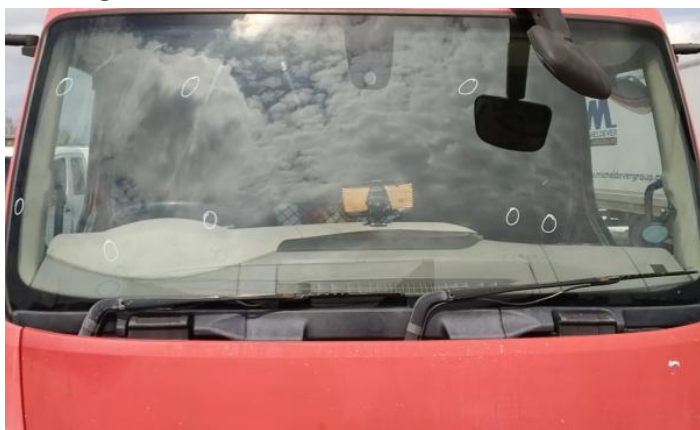
1: Screen Front  
Chipped  
Over 10mm

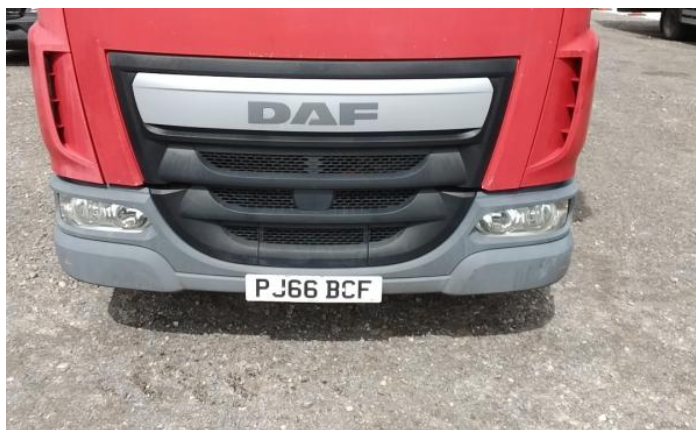
2: Bonnet  
Chipped  
Multiple Chips

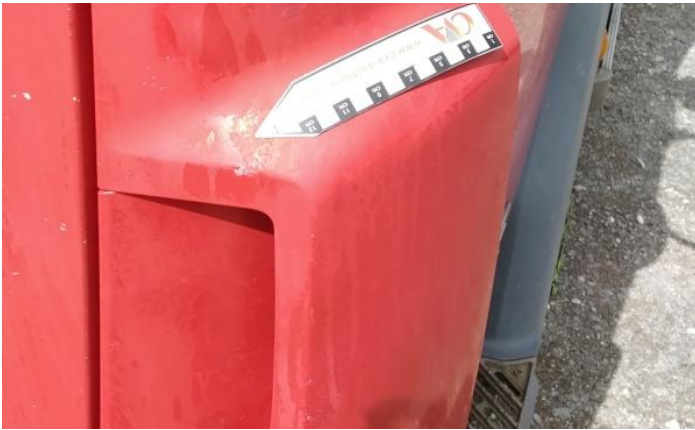
3: Moulding nsf Wing  
Scratched (Painted)  
Over 25mm Thru Paint

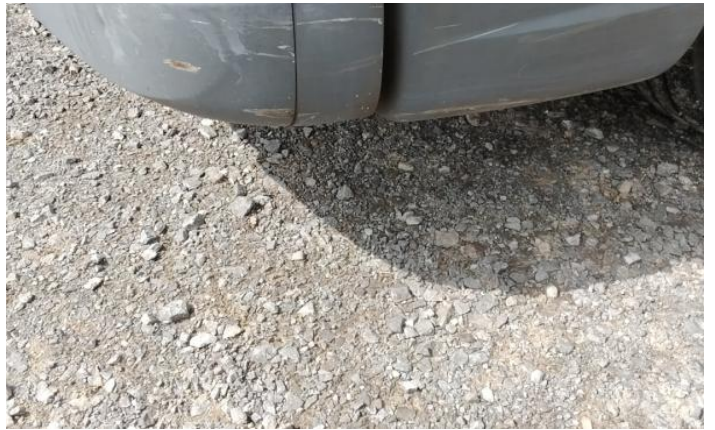
4: Bumper Front  
Scratched  
Over 100mm Thru Paint

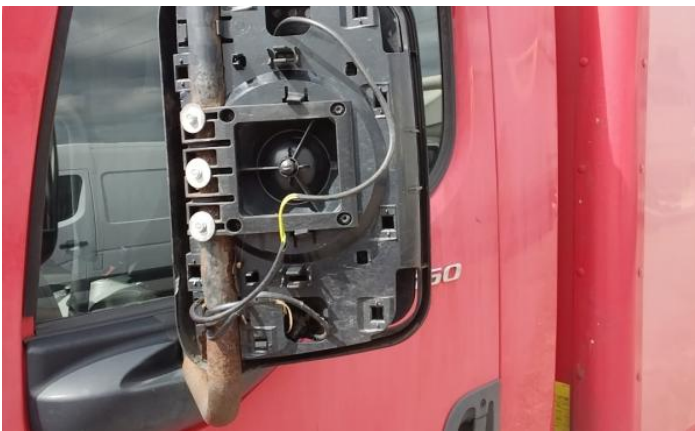
5: Door Mirror Assy nsf  
Broken  
Replace

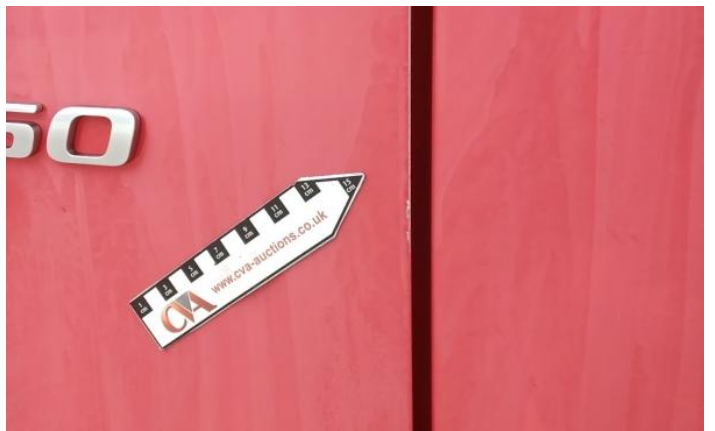
6: Door nsf  
Chipped  
Multiple Chips

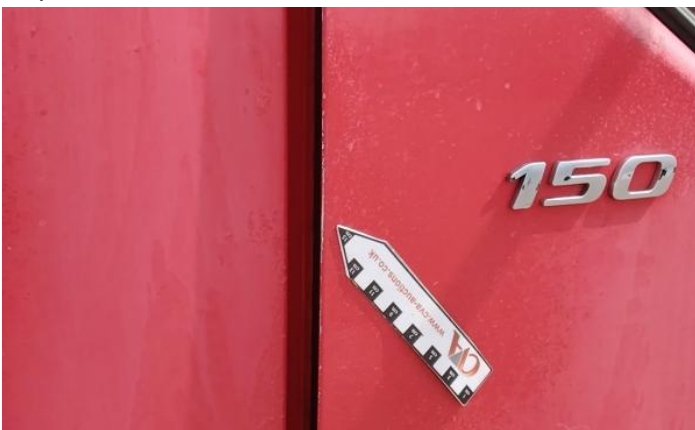
7: Door osf  
Chipped  
Multiple Chips

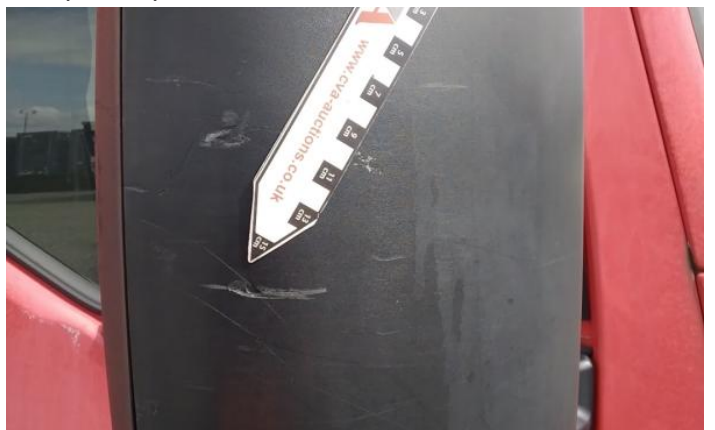
8: Door Mirror Assy osf  
Scratched (Painted)  
Over 25mm Thru Paint

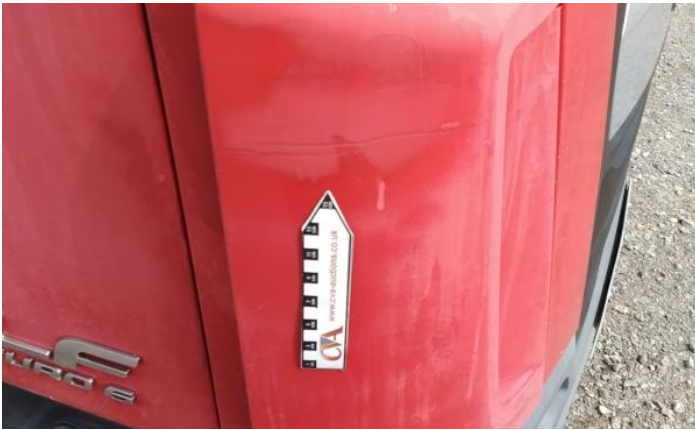
9: Moulding osf Wing  
Scratched (Painted)  
Over 25mm Thru Paint

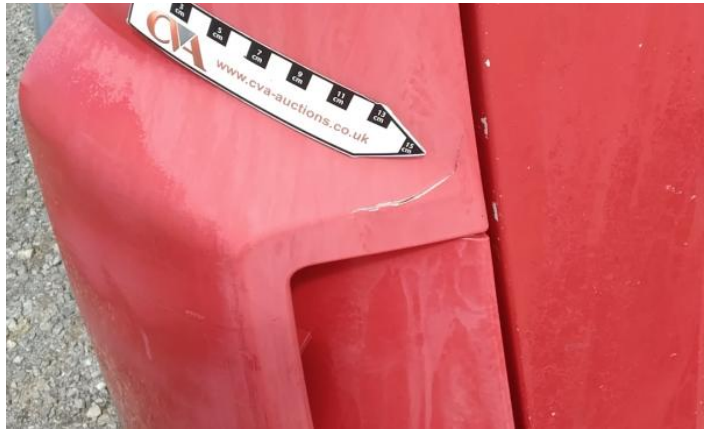
10: Moulding osf Wing  
Broken  
Replace

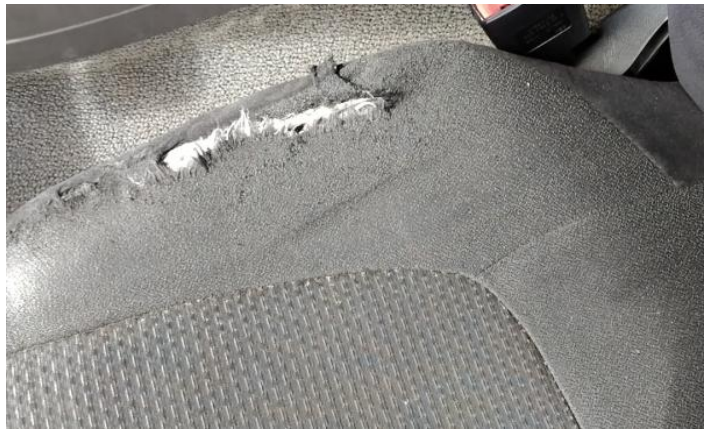
12: Seat Base Cover nsf  
Holed  
Over 3mm

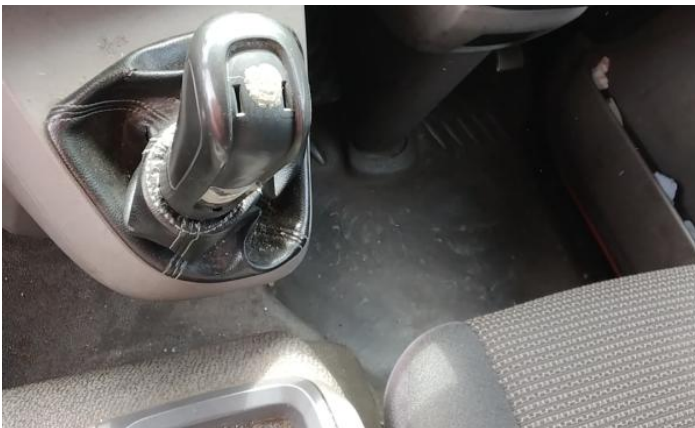
13: Fascia Trim  
Missing  
Replace

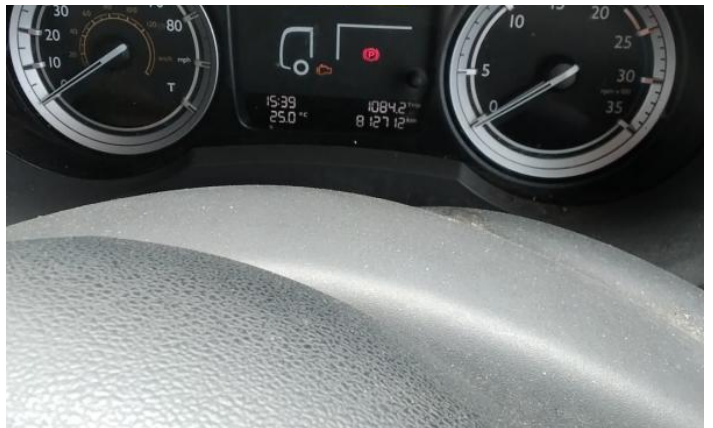
\*NON-RUNNER - CAT/SCR - NOT DRIVEABLE, OIL PRESSURE LOW, ENGINE POWER REDUCED, LEAKING HYDRAULIC FLUID WHEN OPERATING TAIL LIFT - WILL NEED TO BE STRAPPED DOWN ON COLLECTION, WARNING LIGHTS ON DASH\*

14: Dash Warning Lights  
Displayed  
No Action
