# VEHICLE INSPECTION REPORT

**RIG5385**

## Daf XF 510

VIN XLRTGH4300G111119

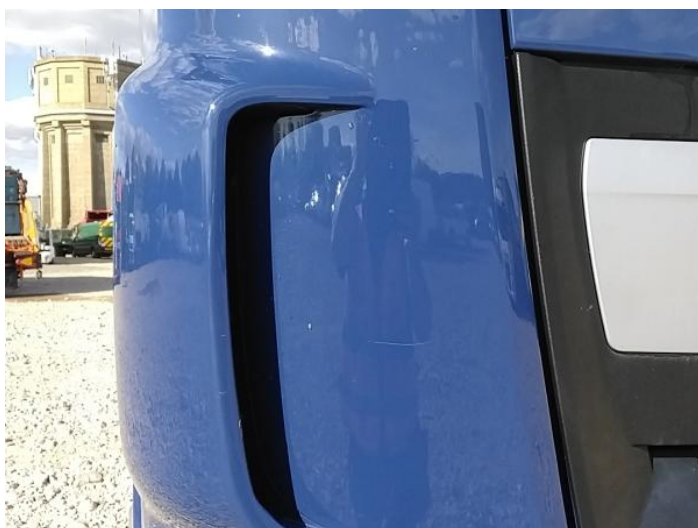
1: Wing osf  
Scratched  
UpTo 25mm Thru Paint

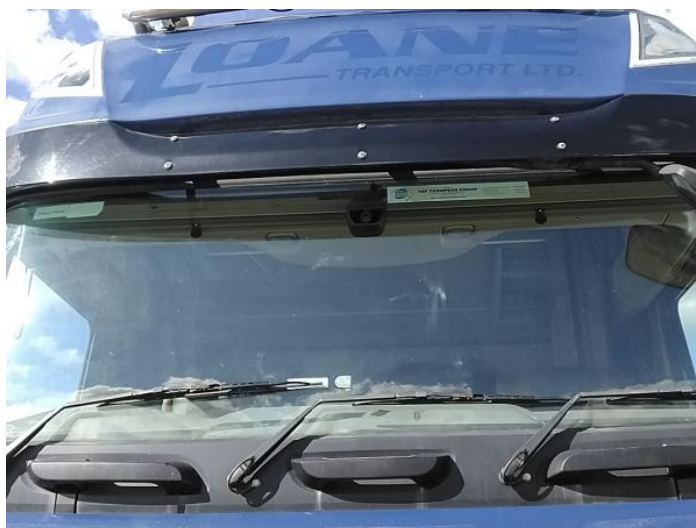
2: Screen Front  
Chipped  
UpTo 10mm

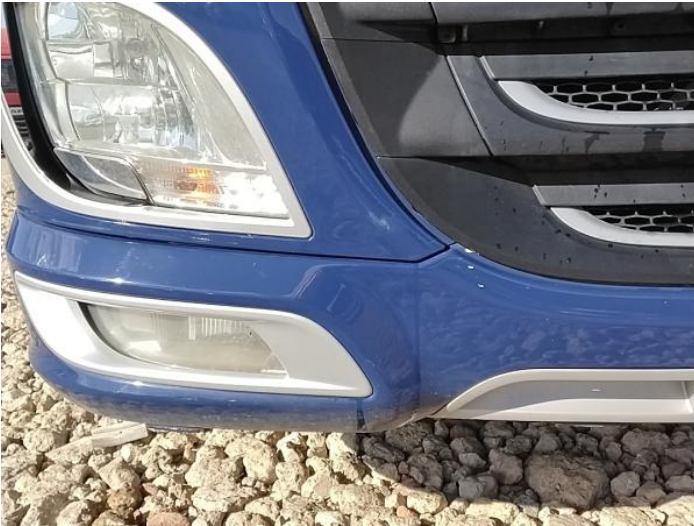
3: Fog Lamp Surround os  
Scratched (Painted)  
UpTo 25mm Not Thru Paint

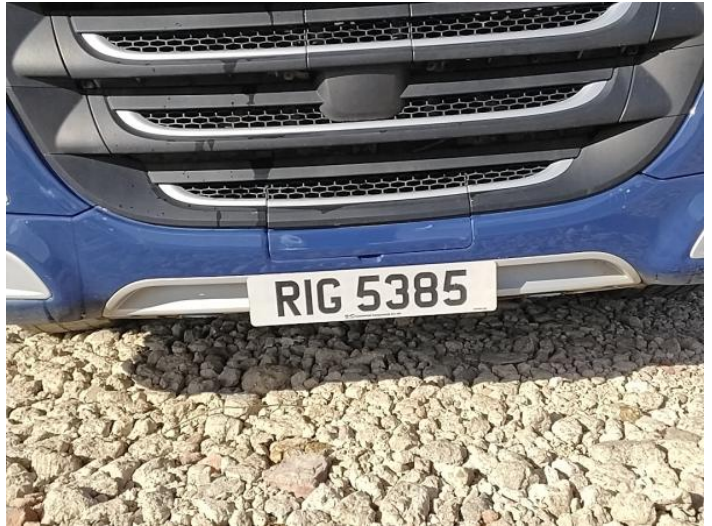
4: Bumper Front  
Scratched  
UpTo 25mm Not Thru Paint

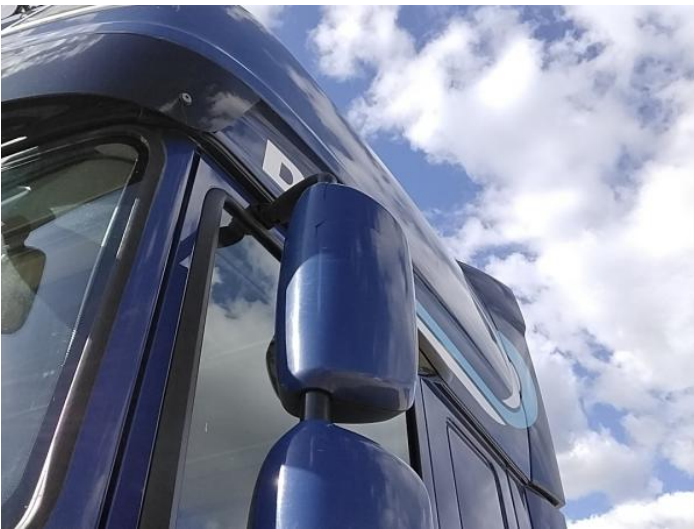
5: Door Mirror Assy nsf  
Broken  
Replace

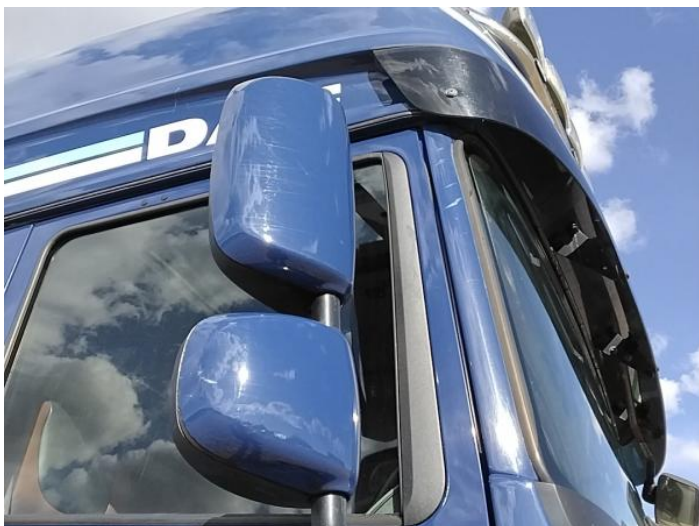
9: Door Mirror Assy osf  
Scratched (Painted)  
Over 25mm Not Thru Paint

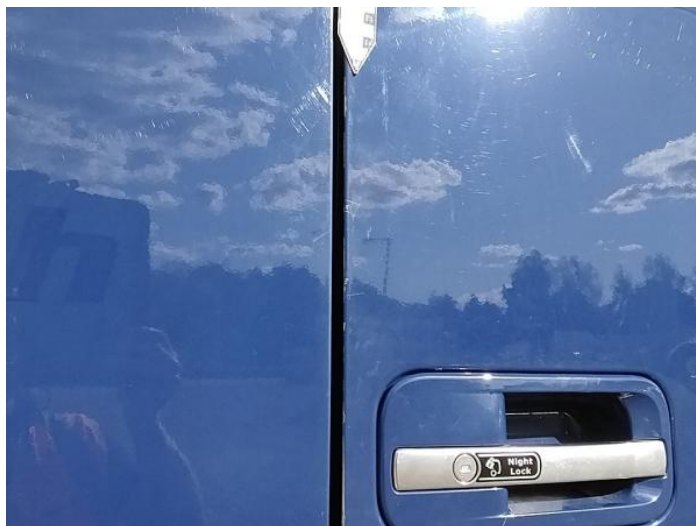
10: Door osf  
Chipped  
Edge Chip

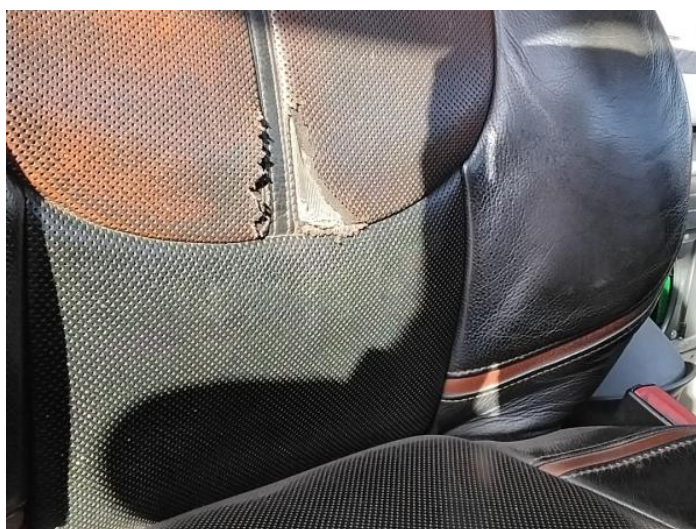
12: Seat Back Cover osf  
Holed  
Over 3mm

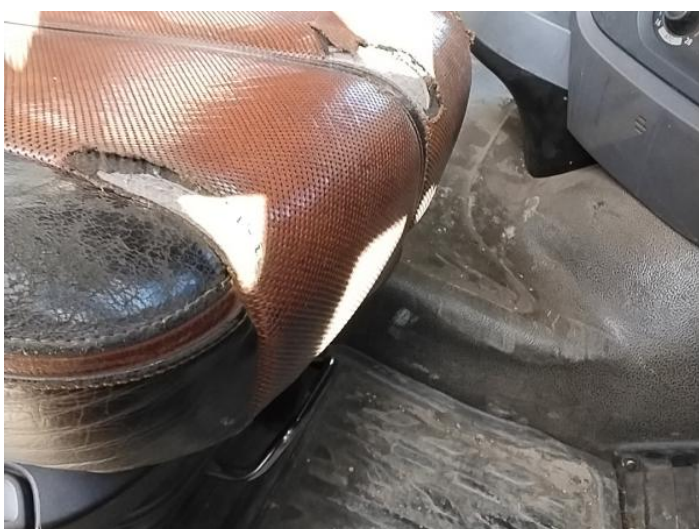
13: Seat Base Cover osf  
Holed  
Over 3mm
