## VEHICLE INSPECTION REPORT

**SA71KJJ**

### Fiat Doblo Work Up 16V II 1.6 MULTIJET

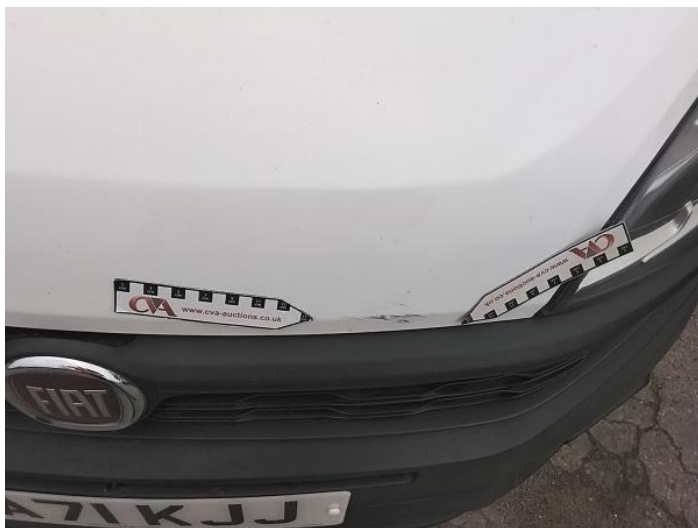
1: Bonnet  
Scratched  
Over 25mm Thru Paint

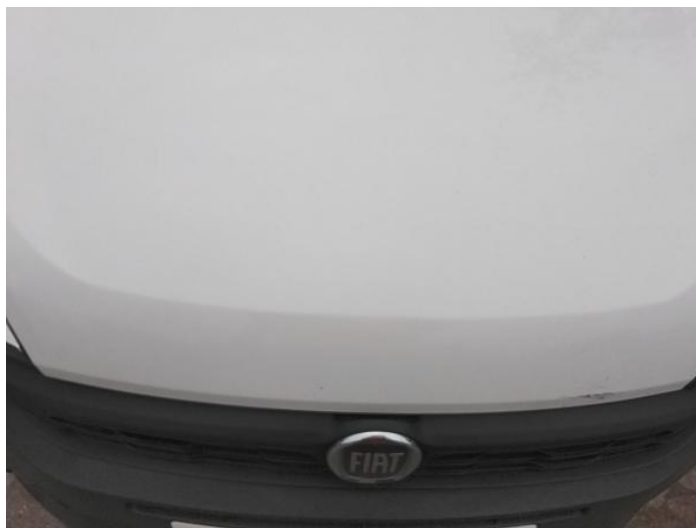
2: Bonnet  
Chipped  
Multiple Chips

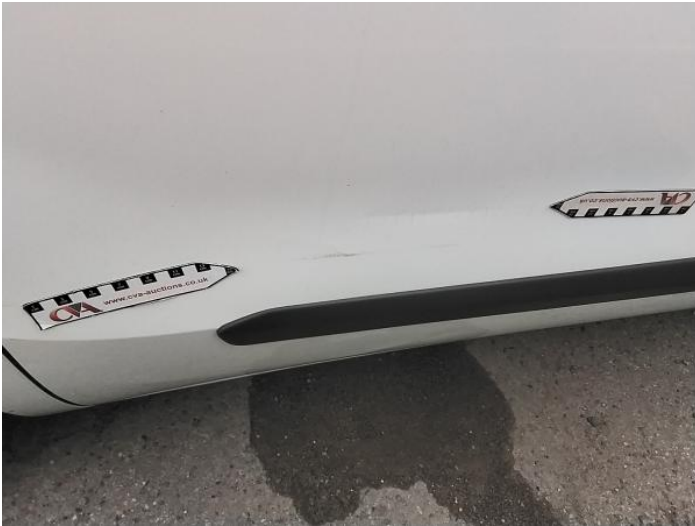
3: Door nsf  
Dented  
Over 30mm

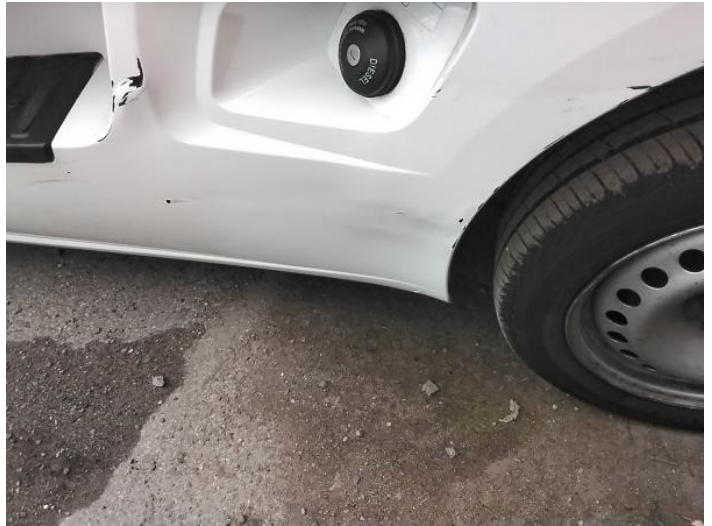
4: Qtr Panel nsr  
Dented  
Over 30% Of Panel

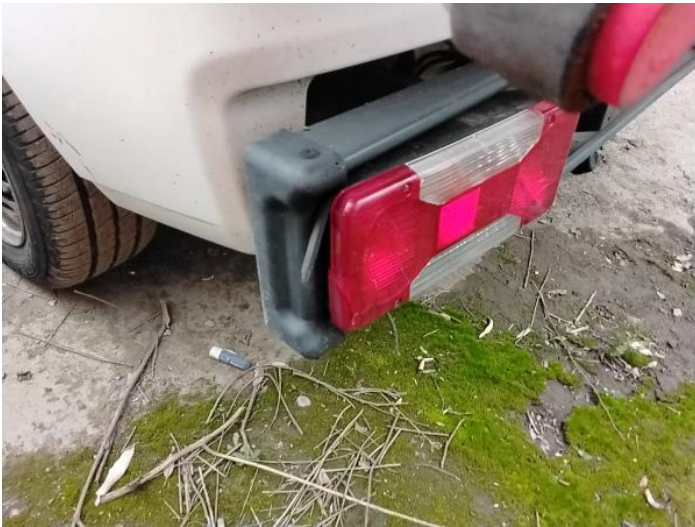
5: Lamp nsr  
Broken  
Replace

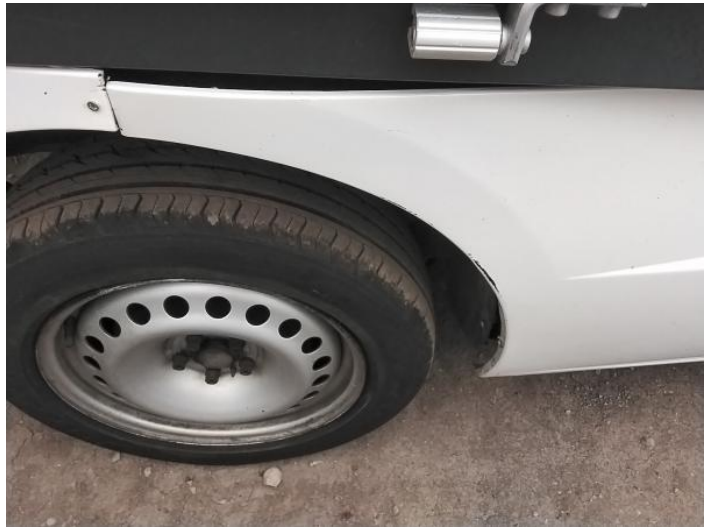
6: Qtr Panel osr  
Scratched  
Over 25mm Thru Paint

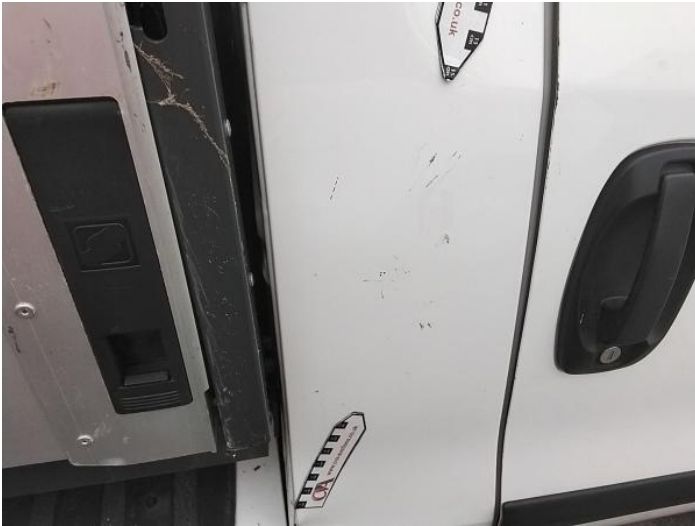
9: B Post os  
Scratched  
Over 25mm Thru Paint

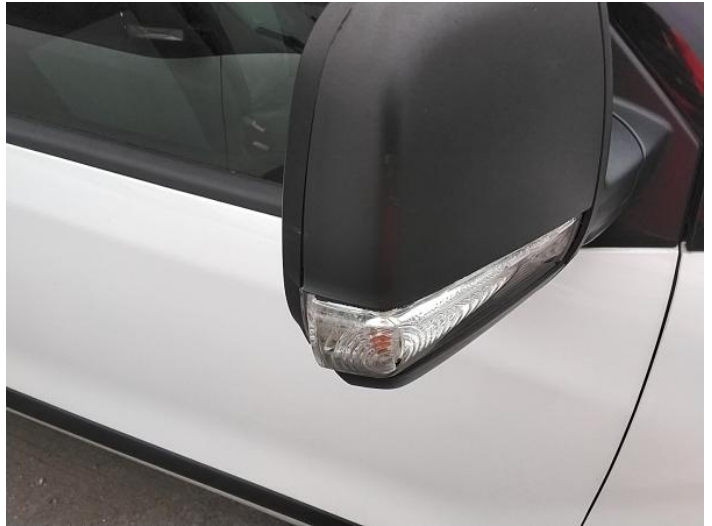
10: Door Mirror Assy osf  
Broken  
Replace

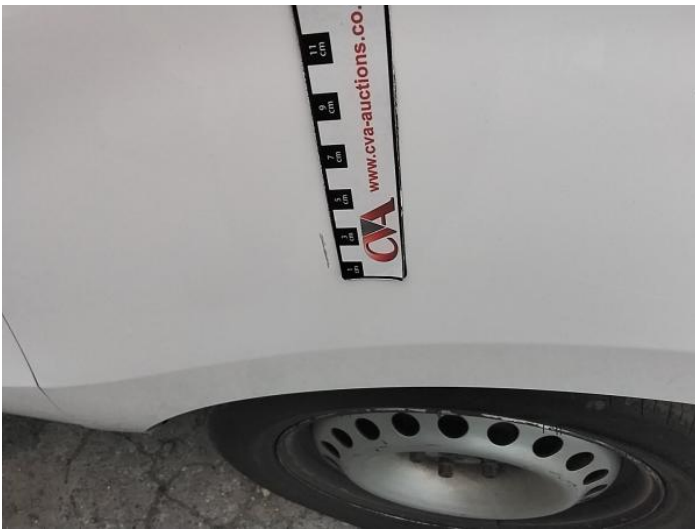
11: Wing osf  
Scratched  
Over 25mm Thru Paint

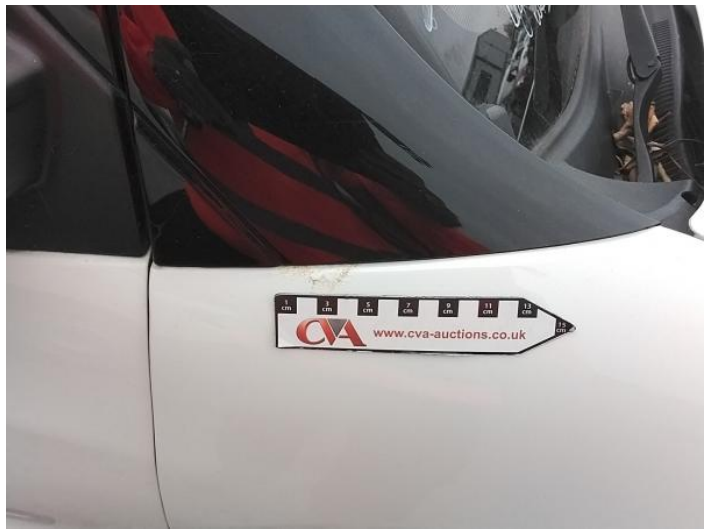
12: Wing osf  
Rusted  
Over 5mm

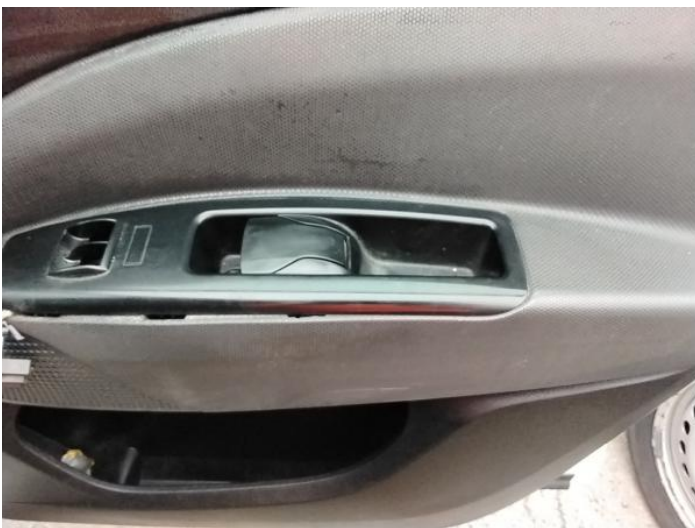
13: Door Pad osf  
Broken  
Replace

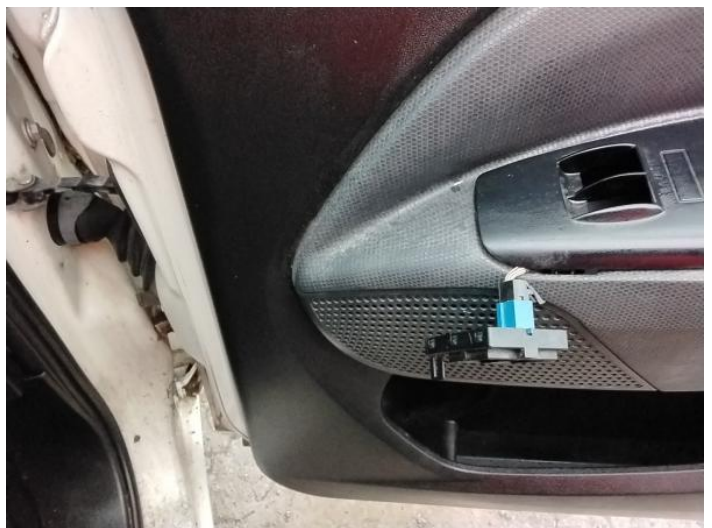
14: Switches And Controls  
Broken  
Replace

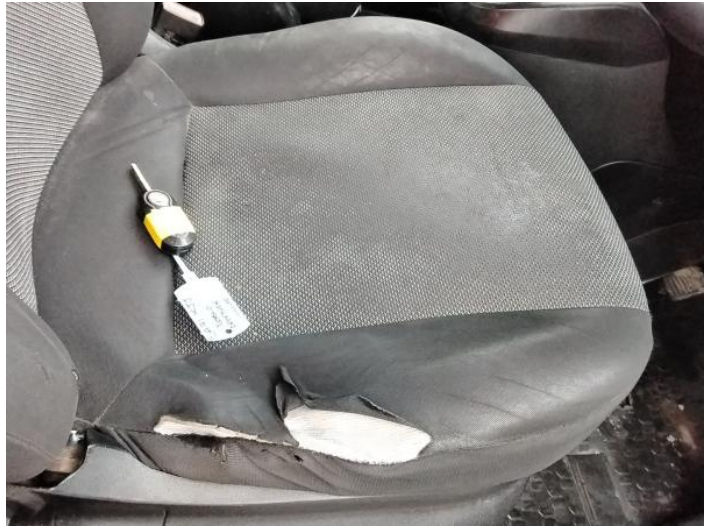
16: Seat Base Cover osf  
Torn  
Over 3mm

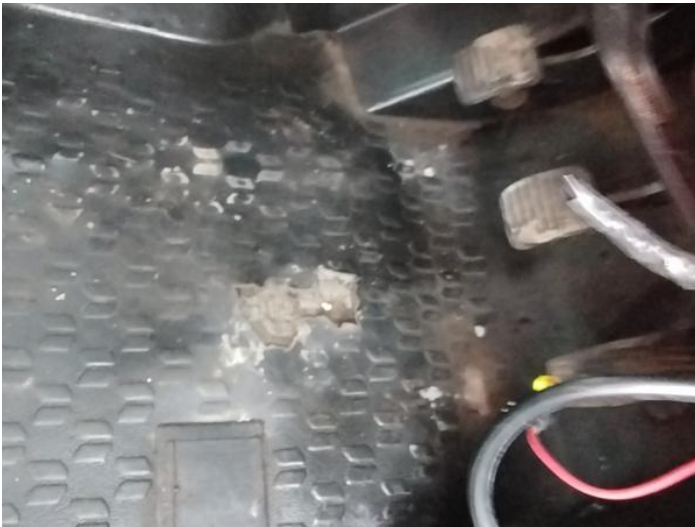
17: Carpets Front  
Holed  
Over 3mm

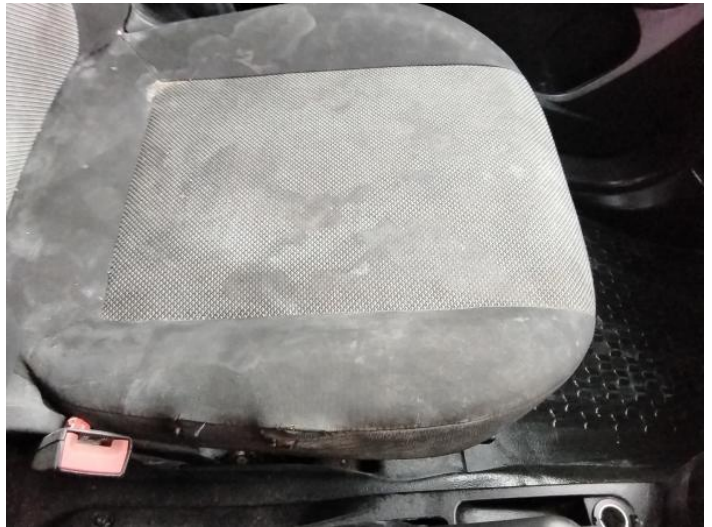
18: Seat Base Cover nsf  
Torn  
Over 3mm

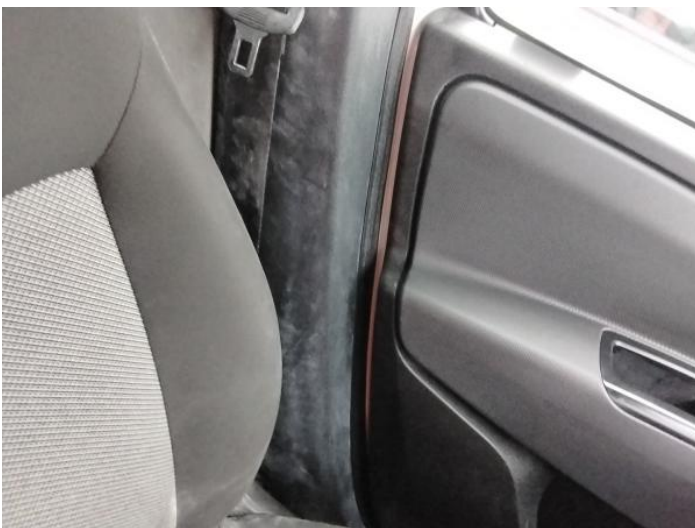
19: Fascia Panel  
Soiled  
Heavy
