# VEHICLE INSPECTION REPORT

**SB15XHR**

## Vauxhall Vivaro 2900 1.6CDTI BiTurbo 120PS ecoFLEX

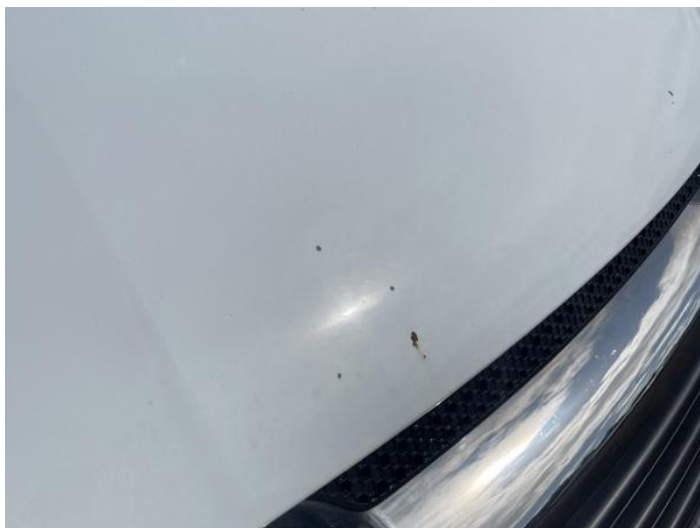
1: Bonnet  
Rusted  
Over 5mm

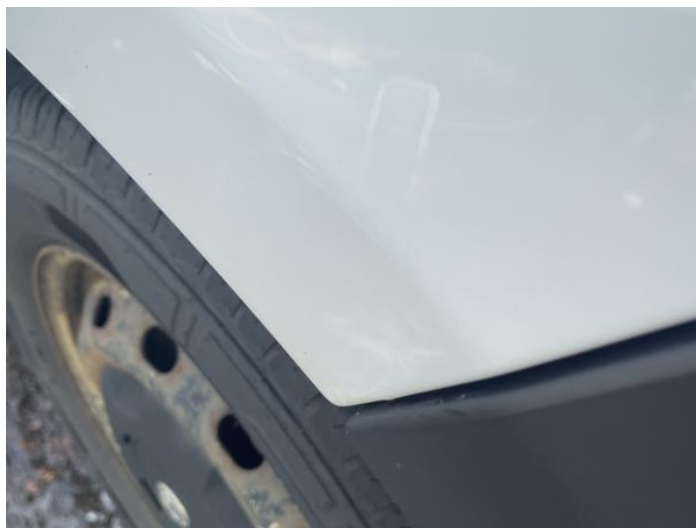
2: Wing of  
Rusted  
Over 5mm

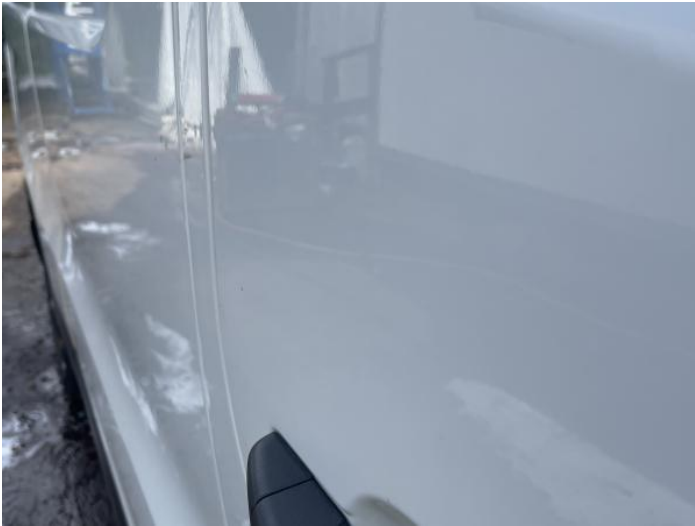
3: Door osf  
Dented  
Over 2 UpTo 10mm

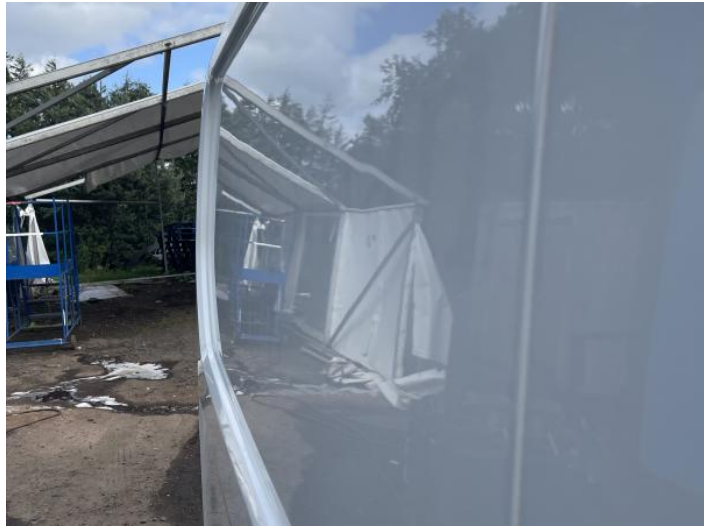
4: Qtr Panel osr  
Dented  
2 Or Less UpTo 10mm

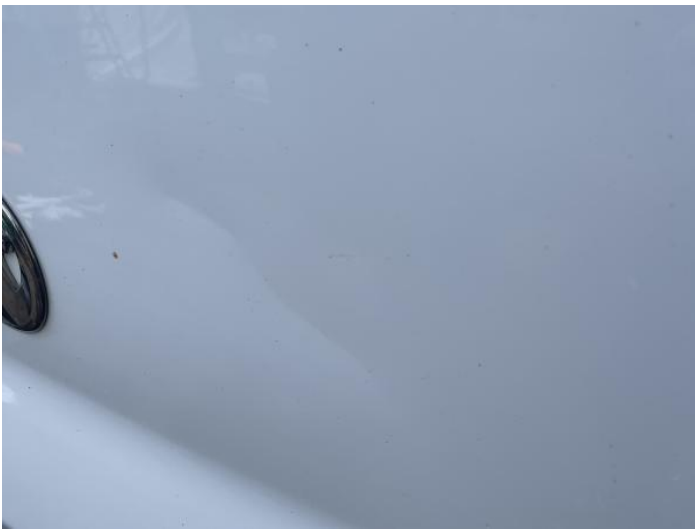
5: Tailgate  
Dented  
Over 30mm

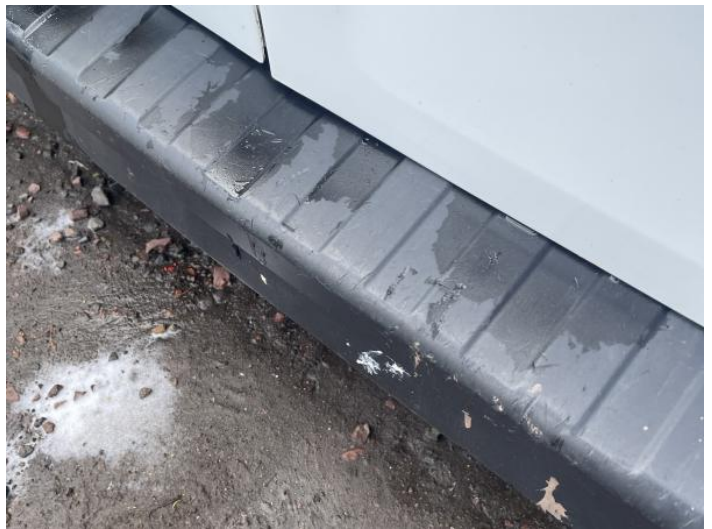
6: Bumper Rear Moulding  
Scuffed (Unpainted)  
UpTo 100mm

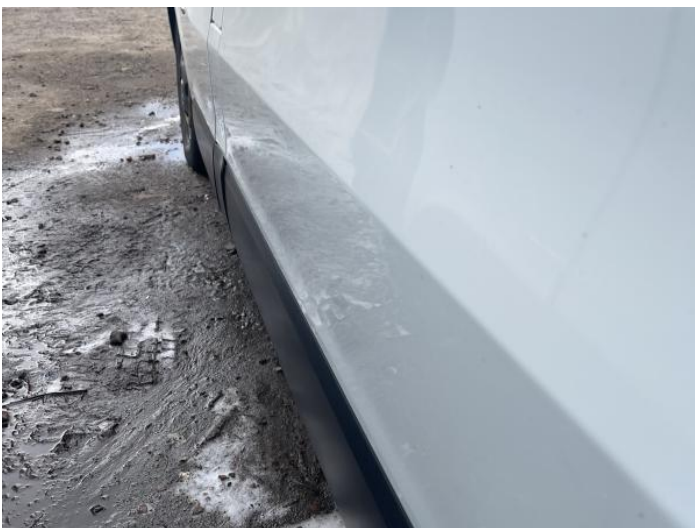
7: Door nsr  
Dented  
Over 30mm

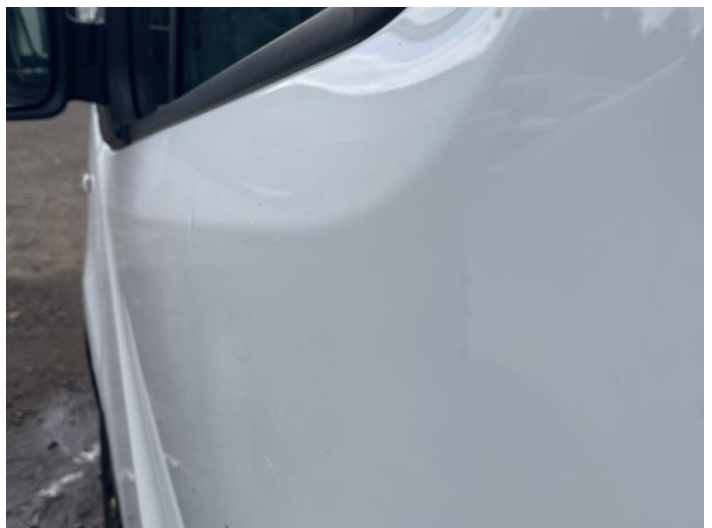
8: Door nsf  
Dented  
Over 2 UpTo 10mm

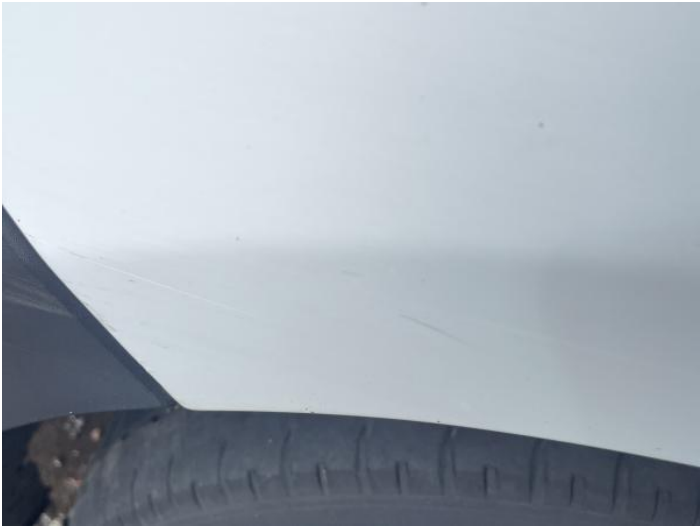
9: Wing nsf  
Rusted  
UpTo 5mm
